Forensic Engineering and Visualization

July 20, 2020

RE: *Crash Reconstruction for Sines v. Kessler*

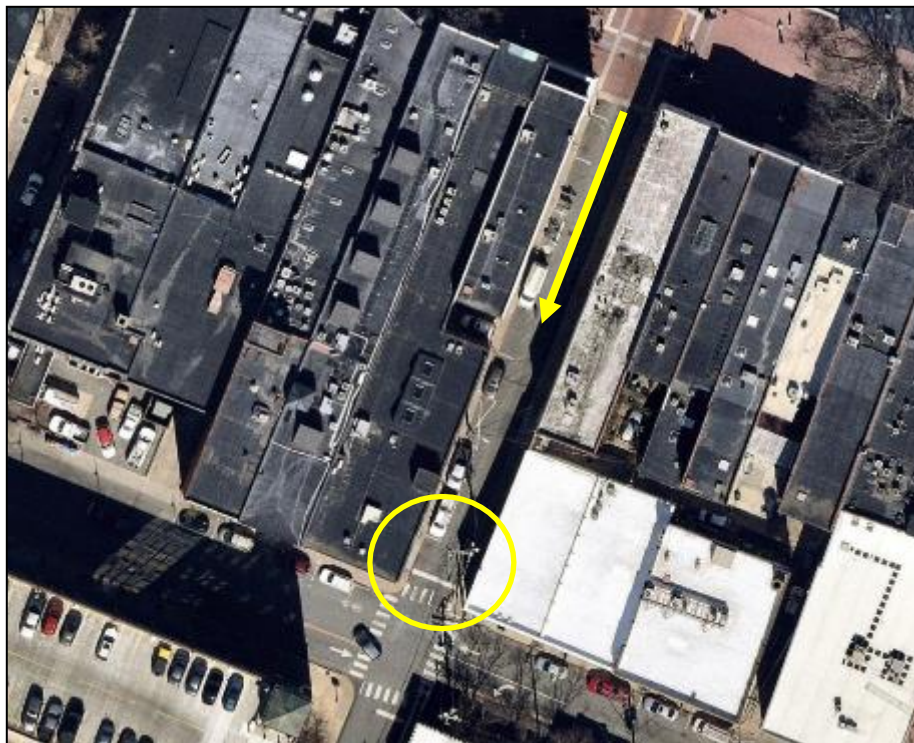
The aerial photograph below (dated March 5, 2018 and obtained from Nearmap) depicts Fourth Street with the area of the crash circled in yellow and the Challenger's direction of travel depicted with a yellow arrow. The incident occurred during daylight and the weather was clear and dry. The speed limit on Fourth Street was 25 mph.

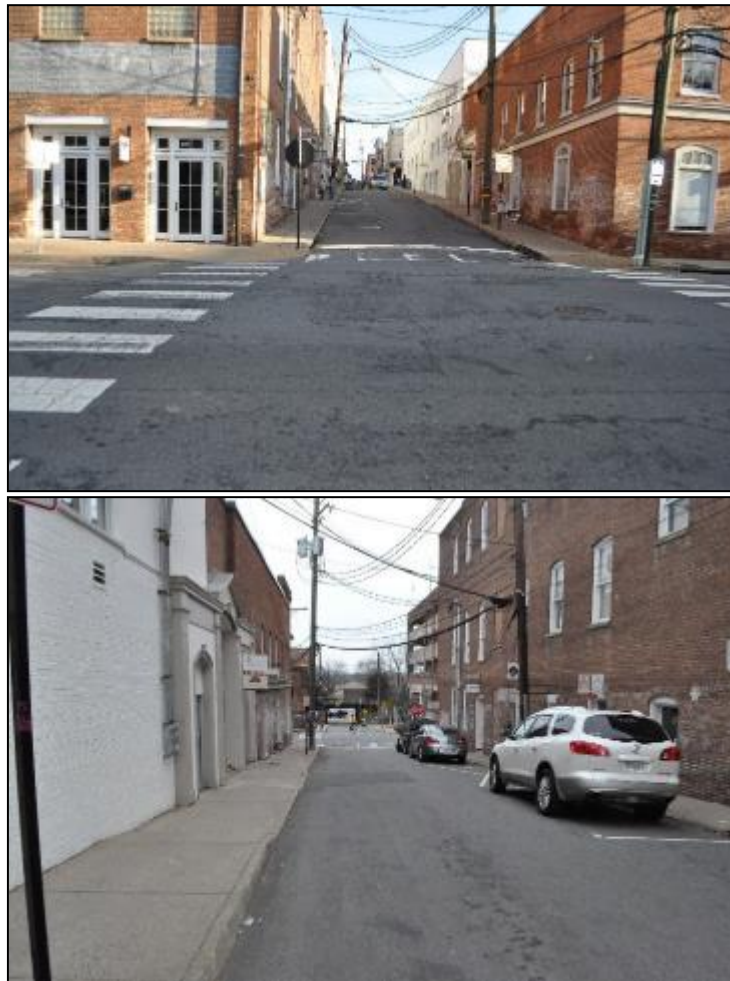
Kineticorp Site Inspection: On February 6, 2019, my team and I inspected, documented, scanned, and photographed the site of the subject crash. During the site inspection, we documented the intersection where the crash occurred. The photographs below were taken during the inspection of the crash site. The photographs depict the subject intersection, facing northbound and southbound, respectively.

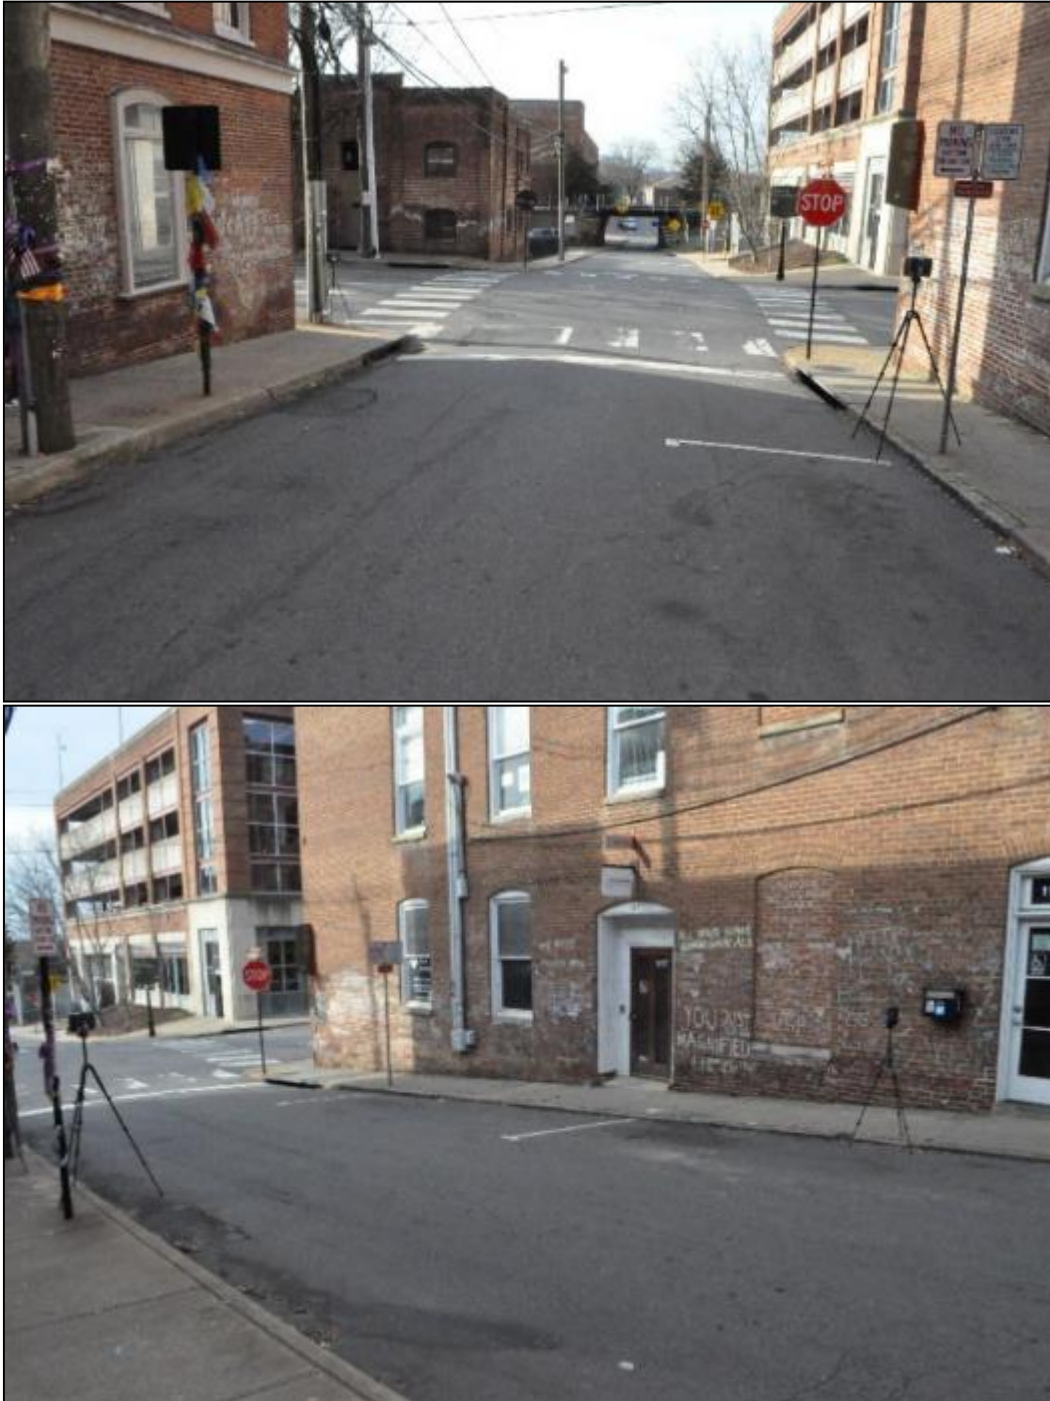
The site was digitized using two Faro Focus high-definition 3D laser scanners. The photographs below show the documentation of the crash site.

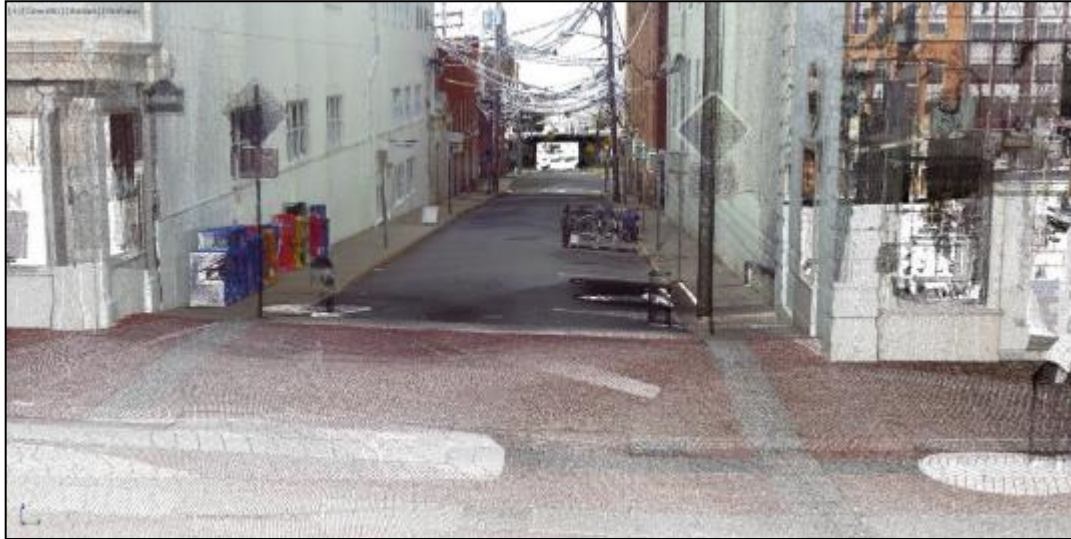
The data from the scanning process was used to produce a 3D computer model of the scene. The model consists of millions of data points representing the 3D geometry. Below is an image showing the data points captured during the scanning process.

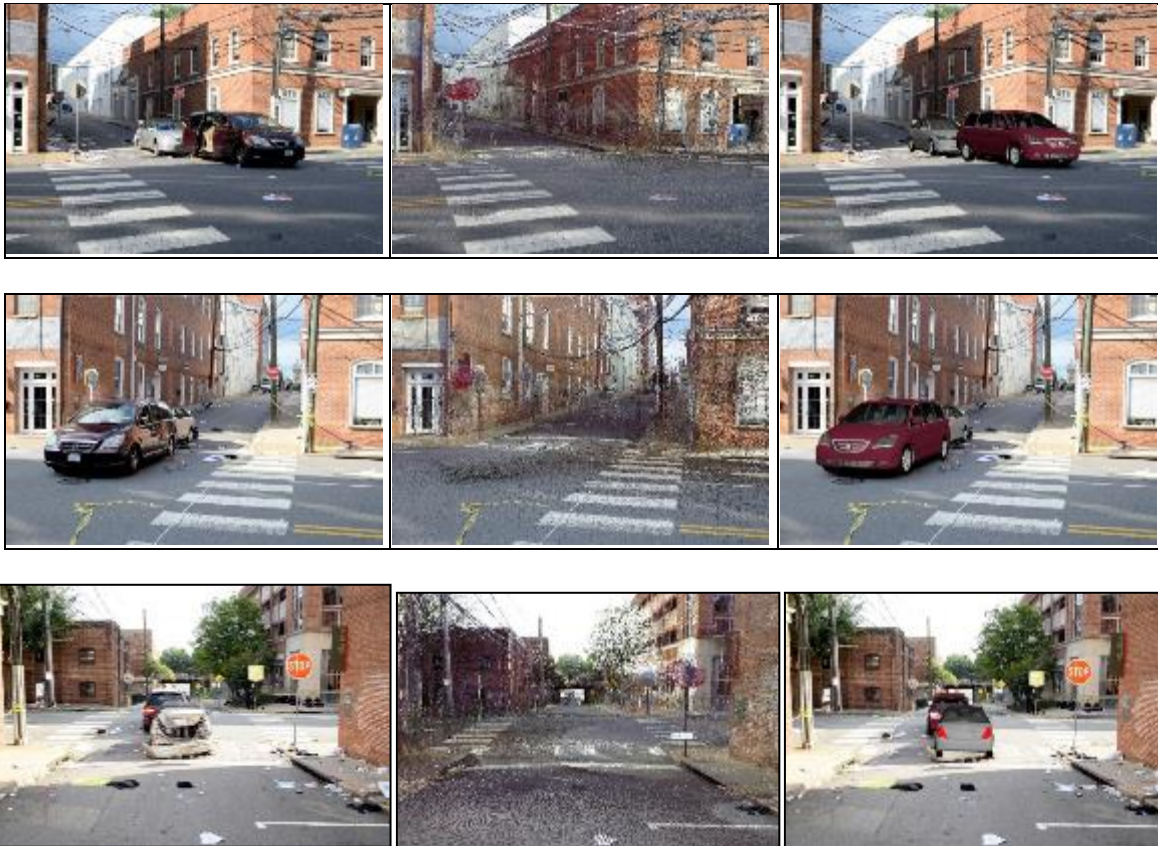
The following images contain a sampling of this photogrammetric analysis. The first image in each row is a photograph taken during the police investigation on the day of the crash. The second image of each row shows the scan data gathered during our scene inspection that has been aligned to the police photo. The third image depicts the photograph overlaid with the 3D computer models of the crash vehicles.

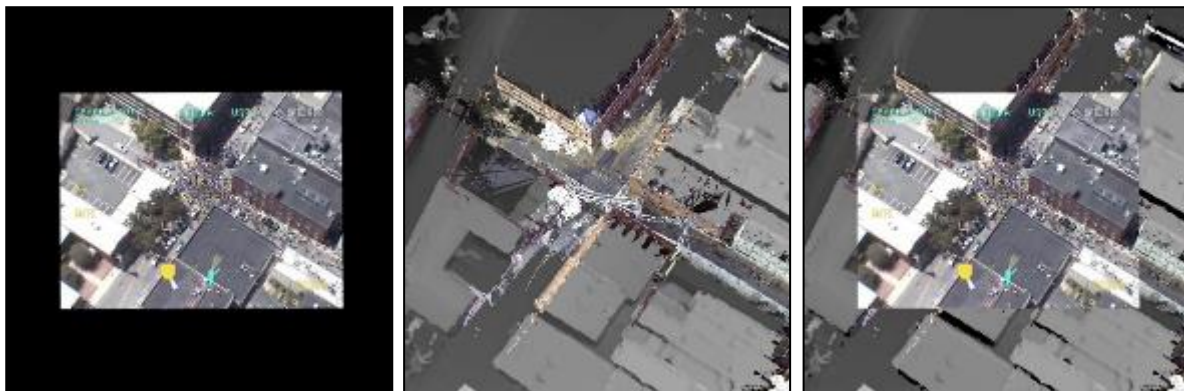
The same process was used to analyze the position of the Challenger in the videos that were provided. With regard to the video taken by helicopter, because the helicopter camera was moving, the video needed to be stabilized relative to the stationary scene which included the buildings and streets. Frames from the video were matched to the stationary scene. The process is shown below with one of the frames from the helicopter video. The first image below is a frame from the police helicopter video. The second image shows the scan data gathered during the scene inspection. The third image depicts the video frame overlaid on the 3D computer model of the scene. This process was performed on all the video frames starting when the Challenger came into view, through impact with the Camry.

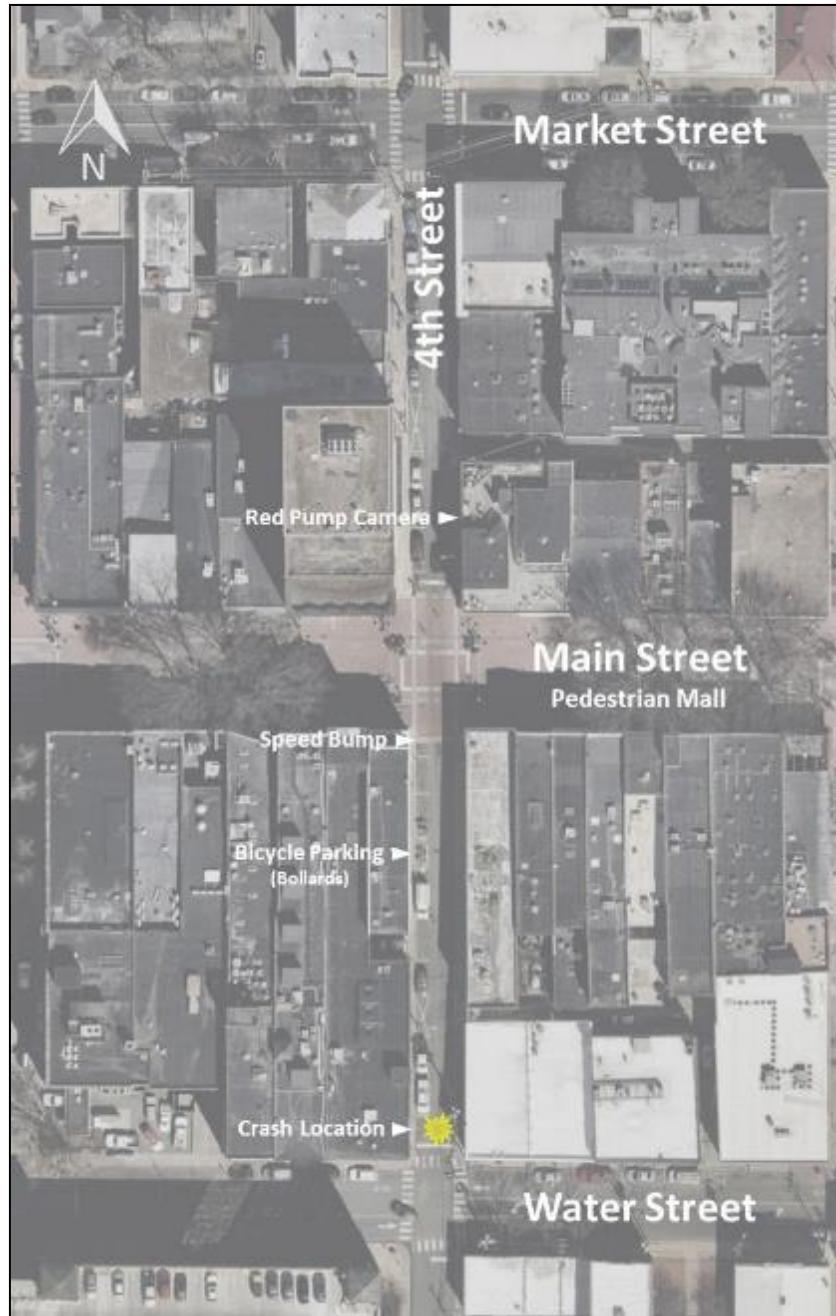
The aerial photo below depicts the configuration of the crash site. The crash location is at the intersection of Water Street and Fourth Street.

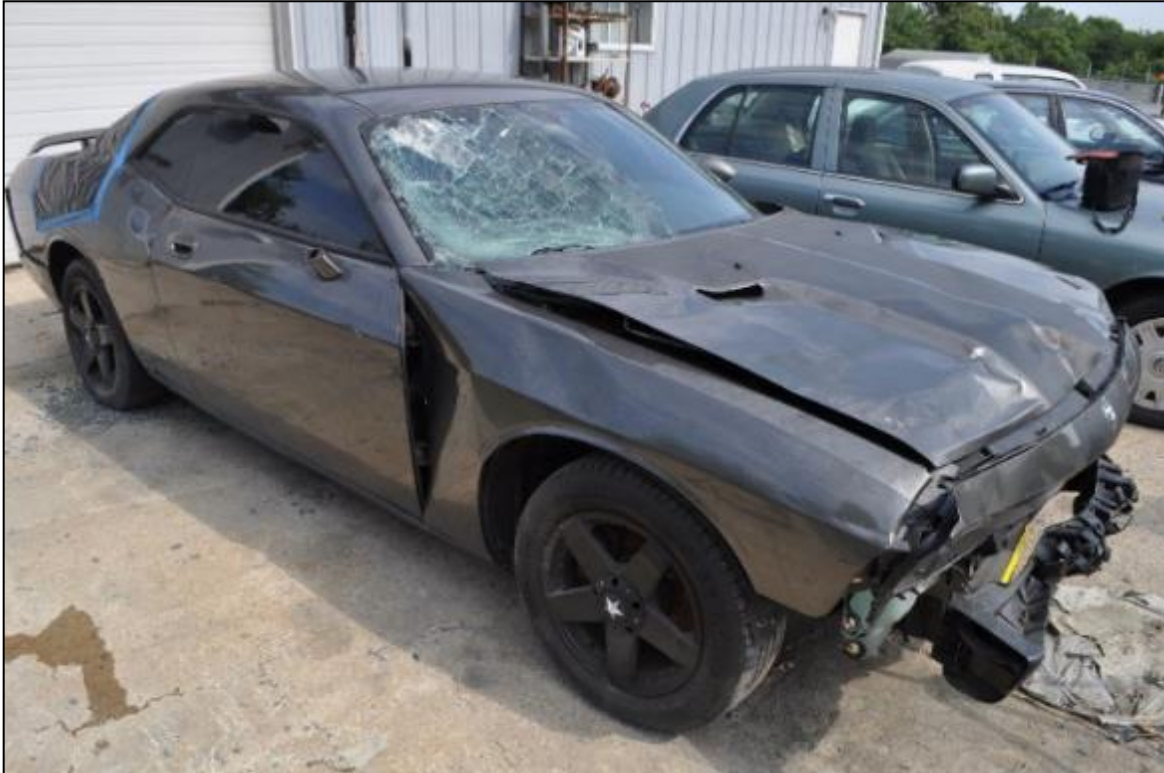
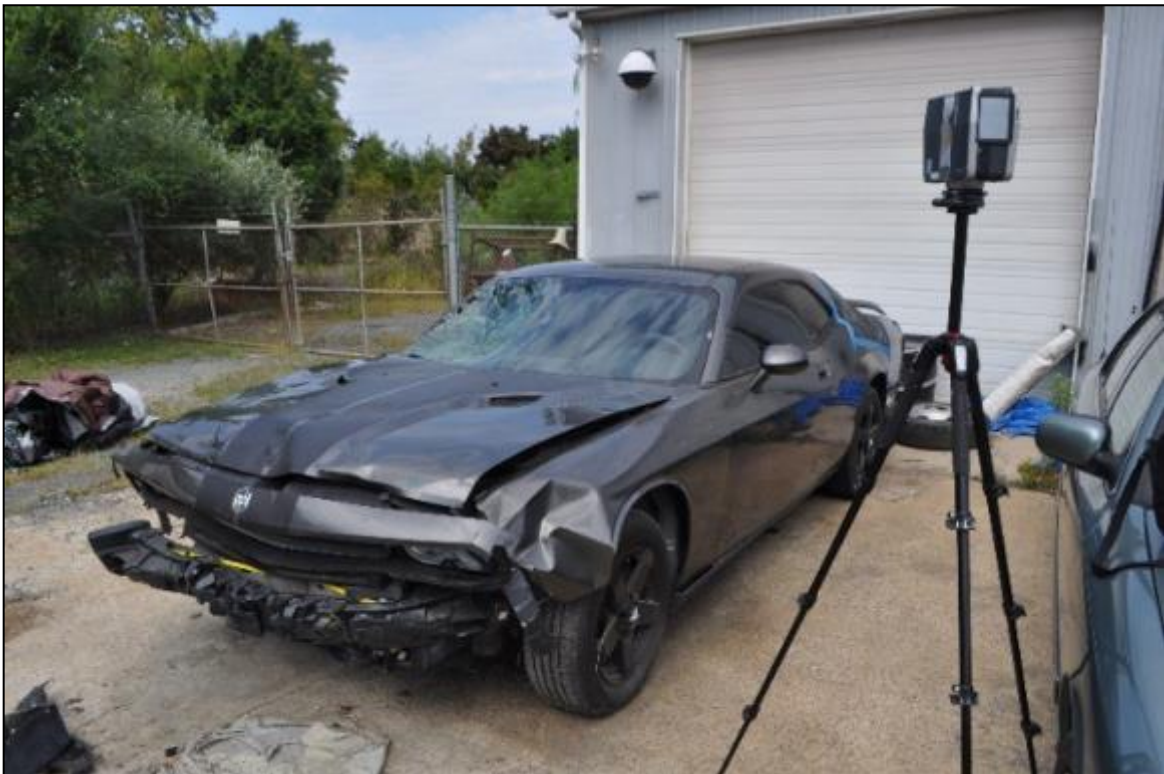
Dodge Challenger: The subject vehicle was a 2010 model year Dodge Challenger, 2-door sedan (VIN – 2B3CJ4DV8AH111921). It was equipped with a 3.5-liter, six-cylinder, 24-valve engine, and a four-speed automatic transmission. The Challenger was inspected by Kineticorp, photographed, and laser scanned using a Faro Focus scanner. As seen in the photographs, the Challenger sustained direct contact damage to the front portion of the vehicle and windshield as a result of the collision, which is consistent with photos and videos taken the day of the crash.

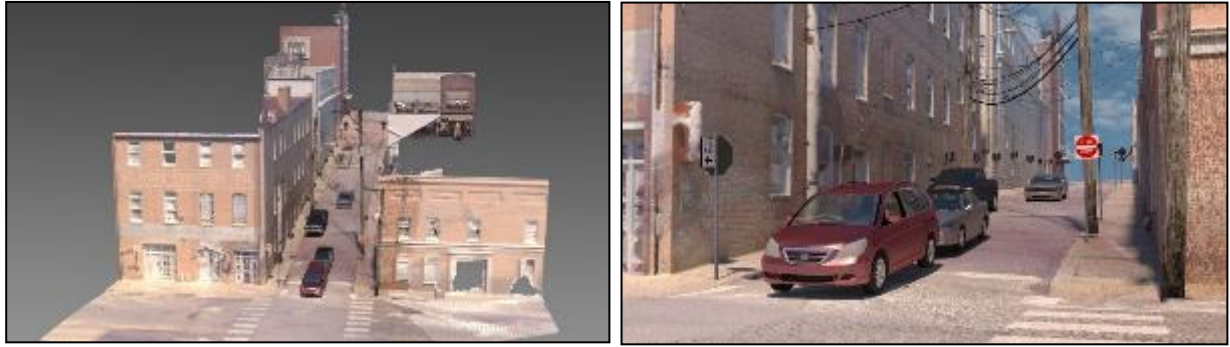
Animation Production: Using the scan data from the scene inspection, a computer model of the crash scene was created. The computer model accurately depicts the true scale of the crash scene such that dimensions can be determined using computer aided drafting ("CAD") software. The computer model is used to show how the crash happened from multiple perspectives. A camera can be placed at any location within the model to view the crash. Below are images of the crash scene.

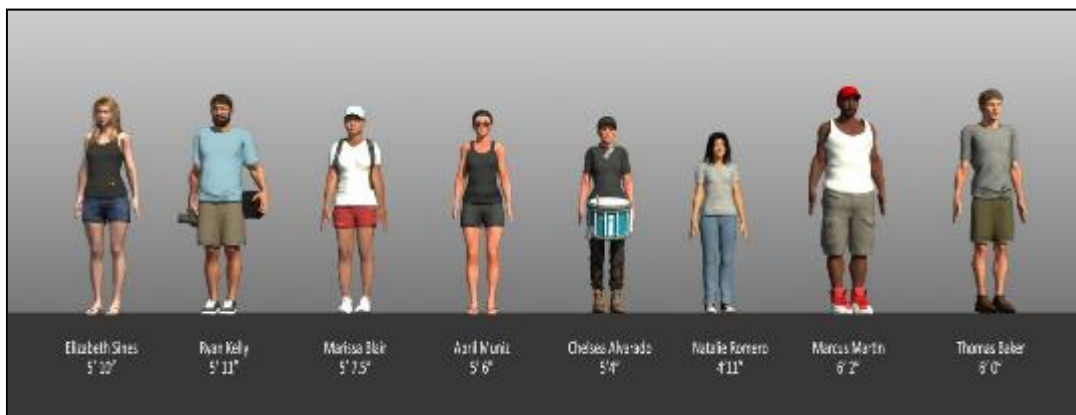
The pedestrians were modeled based on their reported heights and weights at the time of the crash. Scene photographs and videos were also used for modeling. Below is a graphic depicting their descriptions.

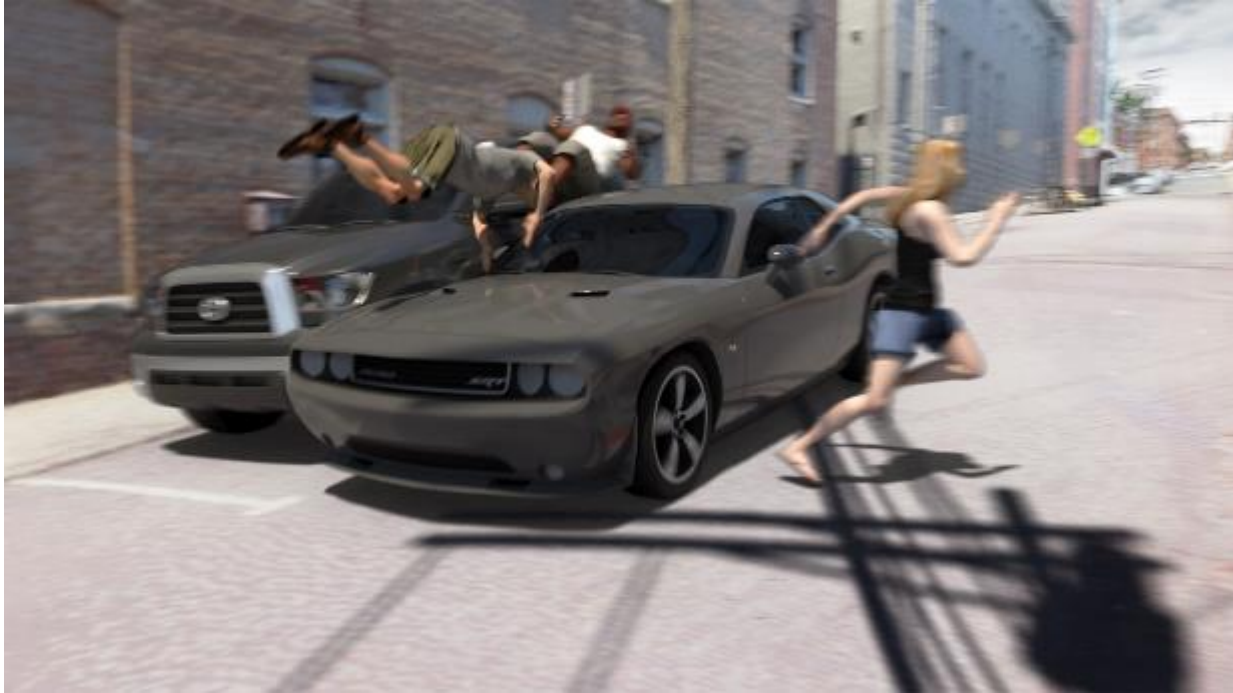
*View from Street Corner*

Several animations were produced to show the impact between the Challenger and the pedestrians, without showing other pedestrians. The animations accompany this report. Frames from the animations are shown below.
